LMS Service Report

Site Name: Lower Longwood Lake

Date: 5/14/2024

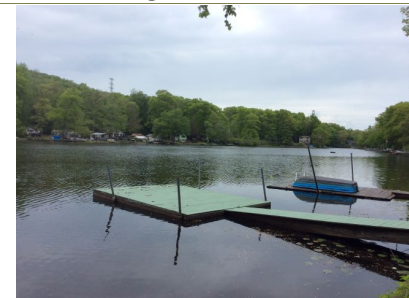
Service Image

Surveyed the lake, observed minor growth of Curly Leaf Pondweed on lower half of the lake. Treated the targeted vegetation with an aquatic herbicide to control the growth.

Past treatment for upper half of the lake is working well. Targeted vegetation is decomposing and being controlled.

L.M.S will return for further management.

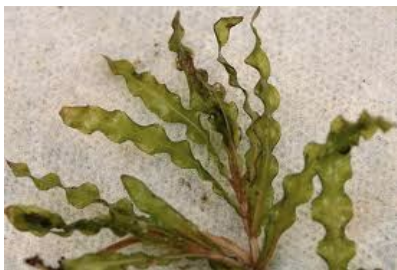
Curly Leaf Pondweed
