## LMS Service Report

Site Name: Lower Longwood Lake

Date: 4/19/2023

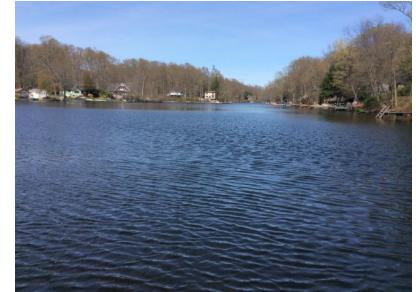
### Service Image

Arrived at site for Spring Surveyed, observed minor growth of Curly Leaf pondweed. No treatment is required at this time. Initial treatment will be applied within the next month.

Overall condition of the lake is good.

L.M.S will return for further management.

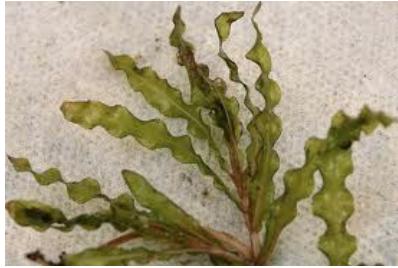
Curly Leaf Pondweed
