## Service Report

Site Name: Lower Longwood Lake

Date: 7/1/2020

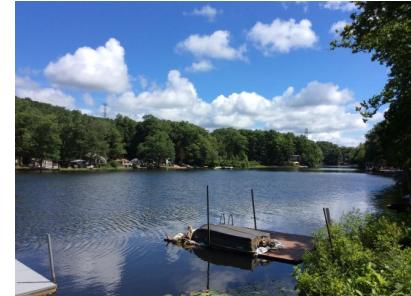
### **Service Image**

Surveyed the lake. Observed minor growth of decomposing Eurasian Milfoil and Filamentous Algae. Applied algaecide and aquatic herbicide to control the growth. Targeted plants are continuing to decompose. Past treatments are working well.

Also applied, aquatic herbicide to control the growth of Large Leaf Pondweed along Yellow Road by the long dock with the yellow tent on it.
