## LMS Service Report

Site Name: Lower Longwood Lake

Date: 6/23/2021

### Description of Work

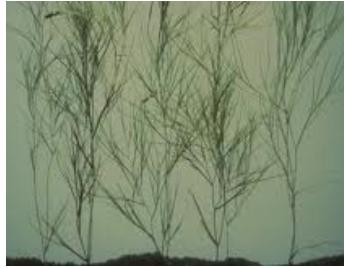
Narrow Leaf Pondweed

Surveyed the waterbody. Observed the minor growth of native Pondweed and Filamentous Algae.  
Treated the targeted nuisance vegetation with an aquatic herbicide and algaecide to help prevent and control the growth.  
LMS will return for further management.

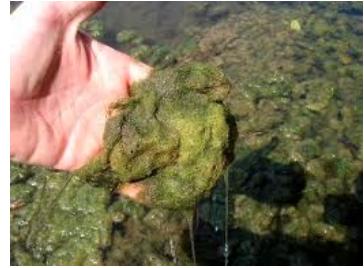
Filamentous
