Service Report

Site Name: Lower Longwood Lake

Date: 6/3/2020

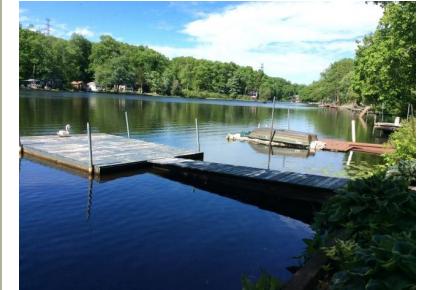
Service Image

Surveyed the lake, observed minor growth of Eurasia Milfoil, Curly Leaf Pondweed and Filamentous Algae 50 yards up from the boat launch, in the cove at the end of Blue road, around dock in middle of lake in front of cove and a patch by the power lines. Treated targeted vegetation with algaecide and aquatic herbicide to help slow and control the growth.

Past treatments are working well, targeted vegetation is continuing to decompose.

A.T. will return for further management.
