LMS Service Report

Site Name: Lower Longwood Lake

Date: 6/9/2023

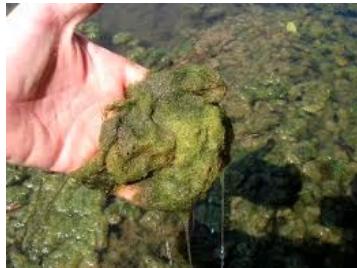
Filamentous

Observed decomposition of plants and surface filamentous algae upon decomposing plant beds in the upper North East Cove.

Applied algaecides to the cove to further control minor filamentous algae populations.
