LMS Service Report

Site Name: Lower Longwood Lake

Date: 9/11/2024

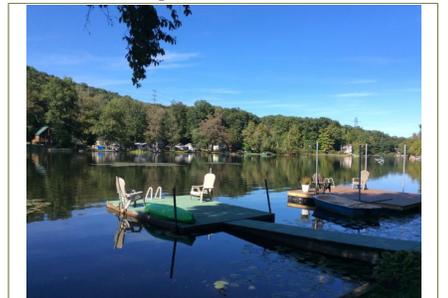
Service Image

Surveyed the lake, observed minor growth of Lyngbya in Blue Rd cove and other spot specific areas of the shoreline. Treated the targeted vegetation with an algaecide to control the growth. Past treatments are working well.

L.M.S will return for further management.

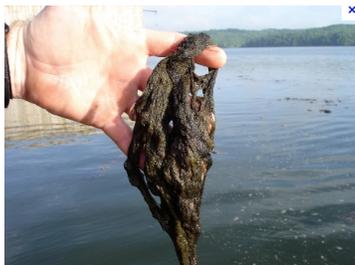
Observed Aquatic Plants & Algae

Lyngbya
